# Briefing on E2 Anchor Bolts – May 8, 2013

THE SAN FRANCISCO-OAKLAND  
**BAY BRIDGE**  
SEISMIC SAFETY PROJECT

# Four Key Questions

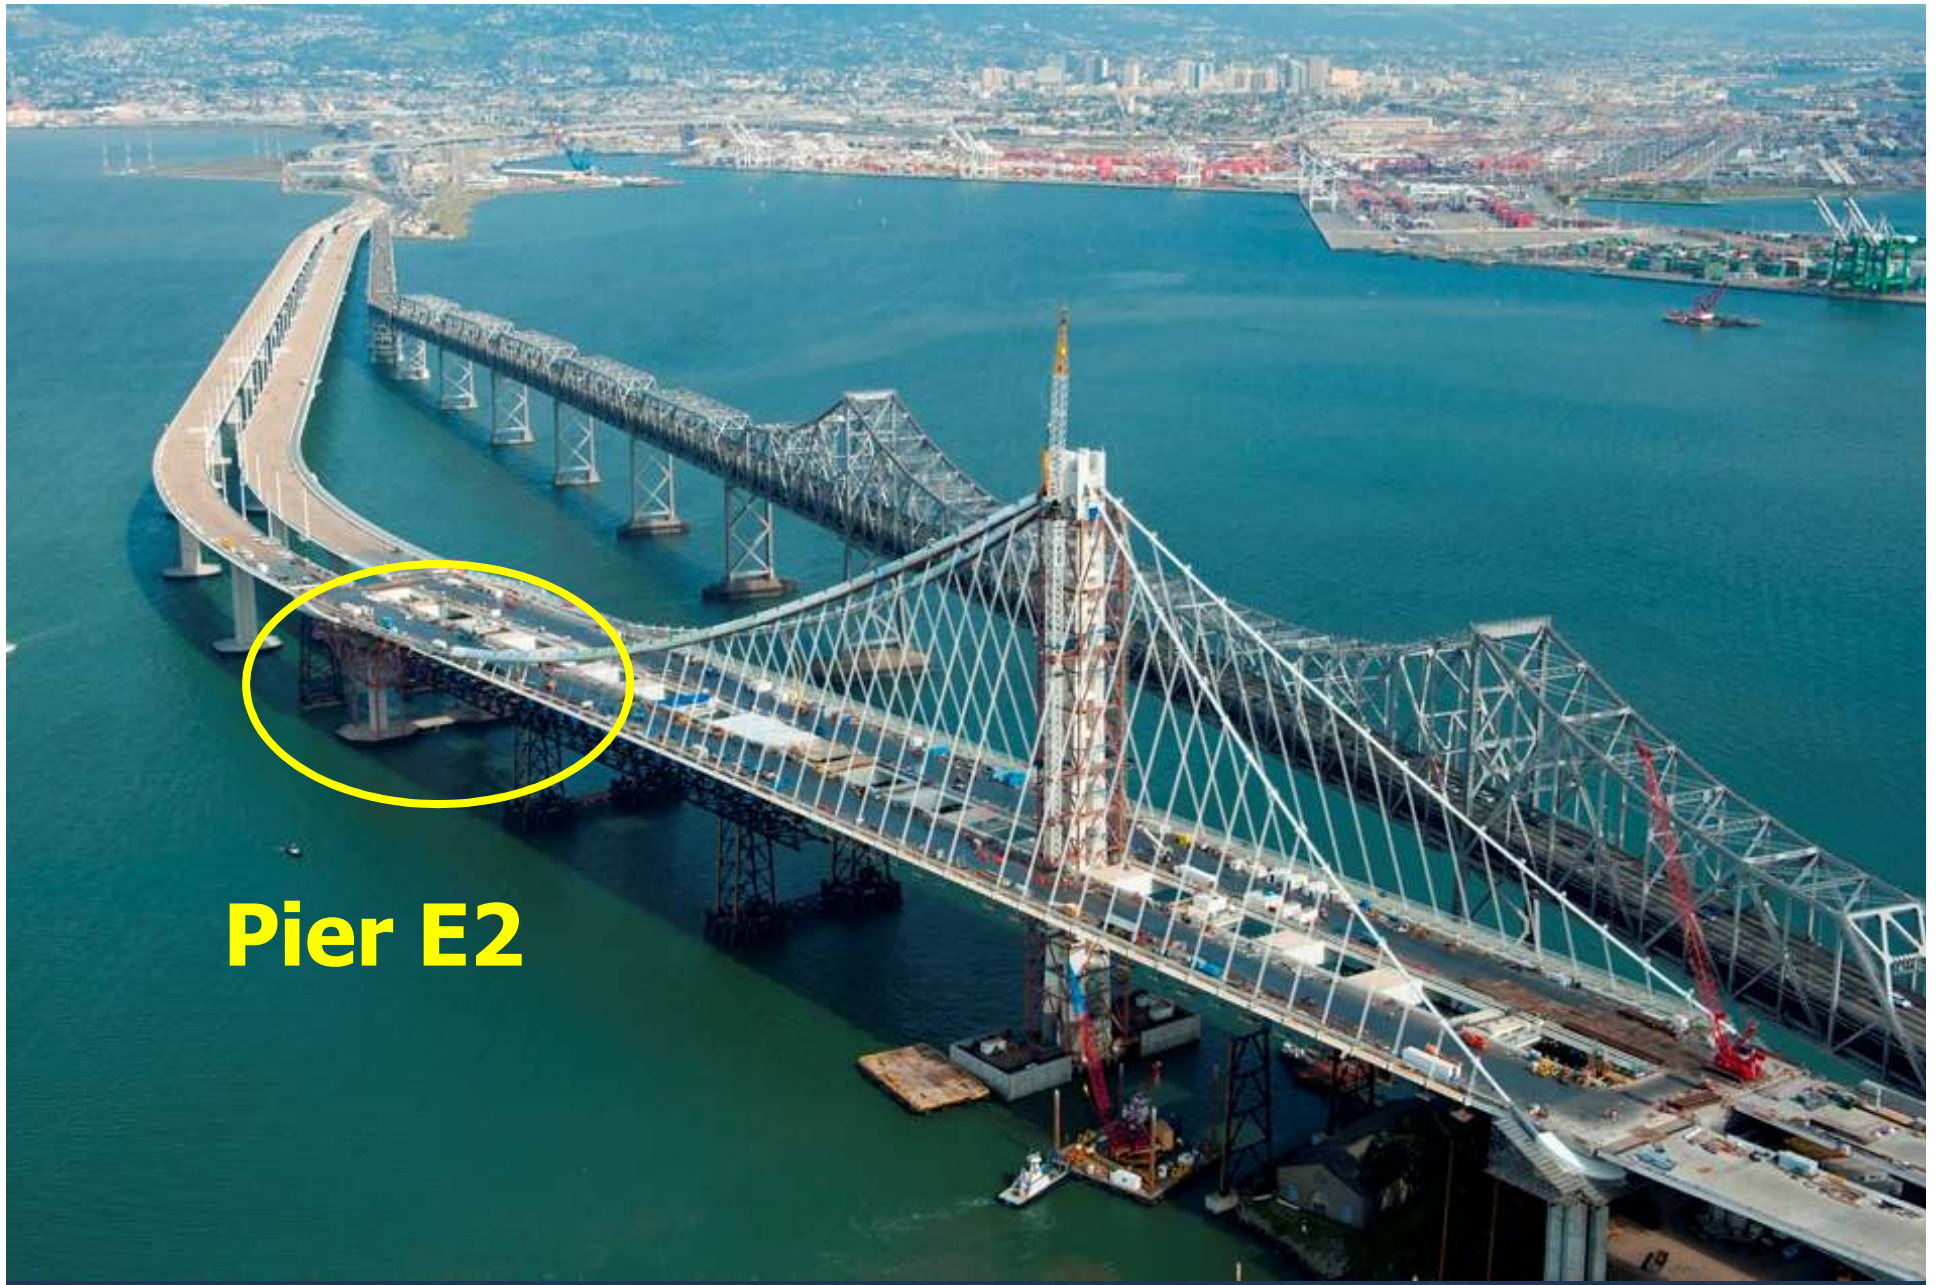
**Pier E2**

- 1. What caused the E2 anchor bolts manufactured in 2008 to fail?**
- 2. What retrofit strategy should be used to replace the 2008 anchor bolts?**
- 3. Should the remaining bolts on the E2 pier manufactured in 2010 be replaced?**
- 4. What should be done about the other A354 BD bolts on the SAS?**
